**Flood Control Project Maintenance
Levee Inspections**
LMA District Cover Sheet
Spring 2018 Levee Inspection Results

Spring 2018 Levee Inspection Results

Sutter Maintenance Yard Nelson Bend

Waterway			Bank	Unit Miles
Unit No. 01 Feather River West Levee - Nelson Bend				0.50
	Spring (March - May)	Summer (June - August)	(September - November) Fall	Winter (December - February)
Unit Maintenance Rating (Fall Only)				
Date of Inspection	4/4/2018 - 4/4/2018			
DWR Inspector	Sterling York			
Accompanied By	Steve Beckley

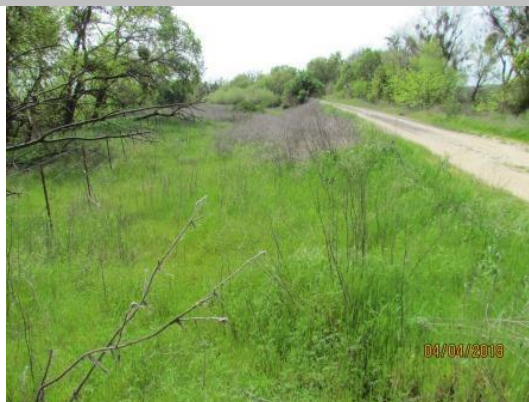
Photo 1 of 1 : SP_2018_ST0006_471_15_20180409_00012.jpg

LM Start	0.02	Rating **	U	Issue No.	15
LM End	0.42	Issue Type +	Ma	Location *	WS
Category	Earthen Levee			GPS Latitude/Longitude	
				Start	End
Item	Vegetation			38.886883 °	38.881287 °
				-121.614797 °	-121.614490 °
DWR ID	DWR_ST0006_01_f_2015_15				
Comment Code					
V2 : Remove the wild growth other than native grasses from the levee slopes.					
Inspector Comment					
Remove the annual vegetation and wild growth. Spring 2018.

View of the vegetation along the waterside slope looking downstream, Spring 2018.

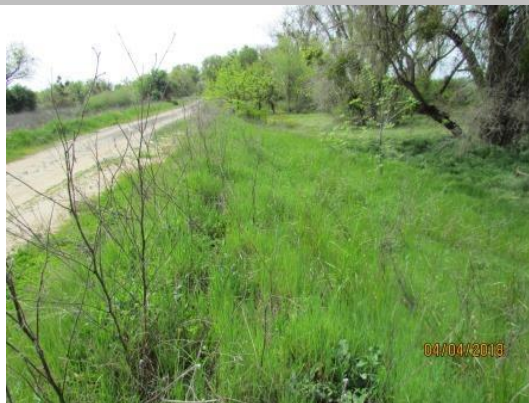
Photo 1 of 1 : SP_2018_ST0006_471_2_20180409_00013.jpg

LM Start	0.02	Rating **	U	Issue No.	2
LM End	0.46	Issue Type +	Ma	Location *	LS
Category	Earthen Levee			GPS Latitude/Longitude	
				Start	End
Item	Vegetation			38.886883 °	38.880833 °
				-121.614797 °	-121.614387 °
DWR ID	DWR_ST0006_01_f_2015_2				
Comment Code					
V2 : Remove the wild growth other than native grasses from the levee slopes.					
Inspector Comment					
Remove the annual vegetation and wild growth. Spring 2018.

View of the vegetation along the landside slope looking downstream, Spring 2018.

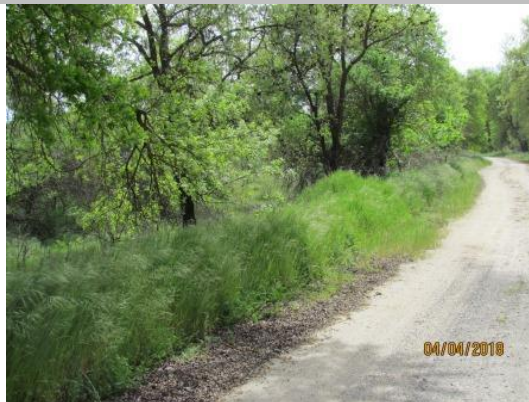
Photo 1 of 1 : SP_2018_ST0006_471_1_20180409_00015.jpg

LM Start	0.13	Rating **	U	Issue No.	1
LM End	0.50	Issue Type +	Ma	Location *	WS
Category	Earthen Levee			GPS Latitude/Longitude	
				Start	End
Item	Trim / Thin Trees			38.885396 °	38.880295 °
				-121.615595 °	-121.614147 °
DWR ID	DWR_ST0006_01_f_2017_1				
Comment Code					
T3 : Trim and thin trees to allow visibility of the ground and room to flood fight.					
Inspector Comment					
Trim up the trees 5 feet for access and visibility, Spring 2018.

View looking downstream waterside of the over growth of trees, Spring 2018.

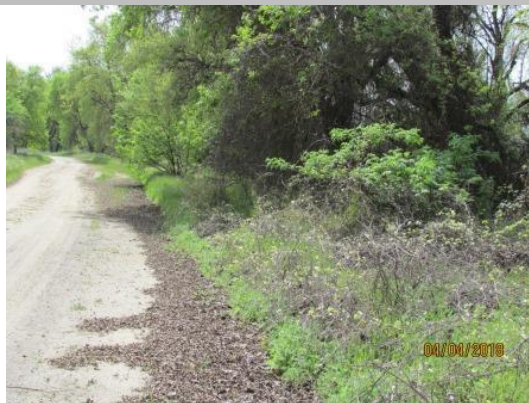
Photo 1 of 1 : SP_2018_ST0006_471_3_20180409_00017.jpg

LM Start	0.13	Rating **	U	Issue No.	3
LM End	0.50	Issue Type +	Ma	Location *	LS
Category	Earthen Levee			GPS Latitude/Longitude	
				Start	End
Item	Trim / Thin Trees			38.885396 °	38.880295 °
				-121.615595 °	-121.614147 °
DWR ID	DWR_ST0006_01_f_2017_3				
Comment Code					
T3 : Trim and thin trees to allow visibility of the ground and room to flood fight.					
Inspector Comment					
Trim up the trees 5 feet for access and visibility, Spring 2018.

View looking downstream landside of the over growth of trees, Spring 2018.

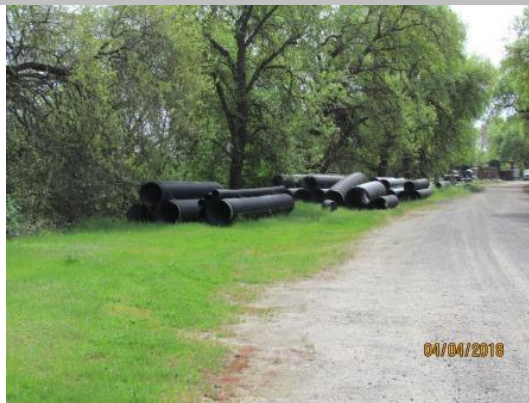
Photo 1 of 1 : SP_2018_ST0006_471_16_20180409_00018.jpg

LM Start	0.40	Rating **	U	Issue No.	16
LM End	0.46	Issue Type +	En	Location *	WS
Category	Earthen Levee			GPS Latitude/Longitude	
				Start	End
Item	Encroachments			38.881638 °	38.880795 °
				-121.614647 °	-121.614427 °
DWR ID	DWR_ST0006_01_f_2015_16				
Comment Code					
DE : Debris					
Inspector Comment					
The large pipe is still laying along the waterside berm, Spring 2018.

View of the pipe along the waterside berm looking downstream. Spring 2018.

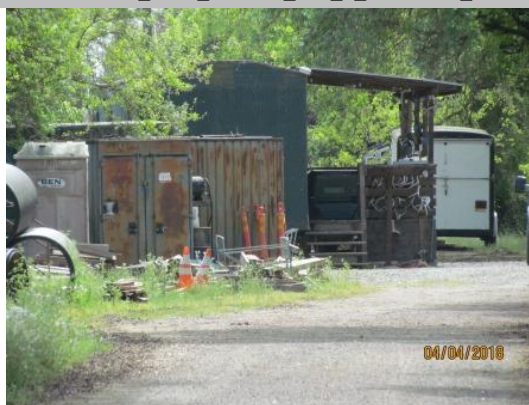
Photo 1 of 1 : SP_2018_ST0006_471_8_20180409_00019.jpg

LM Start	0.47	Rating **	U	Issue No.	8
LM End	0.47	Issue Type +	En	Location *	CR
Category	Earthen Levee			GPS Latitude/Longitude	
				Start	End
Item	Encroachments			38.880664 °	38.880664 °
				-121.614335 °	-121.614335 °
DWR ID	DWR_ST0006_01_s_2012_8				
Comment Code					
BU : Building					
Inspector Comment					
The building is directly behind the pipe that is laying along the waterside berm. Spring 2018.

View of the building directly behind the pipe on the waterside berm looking downstream. Spring 2018.
